MSG 026 (15-0402) - FD05 MISSION SUMMARY

MSG 030A (15-0406A) - FD5 EVA STATUS ITEMS

MSG 028A (15-0404A) - FD04 MMT SUMMARY Page 1 of 3

FD4 MMT Crew Summary

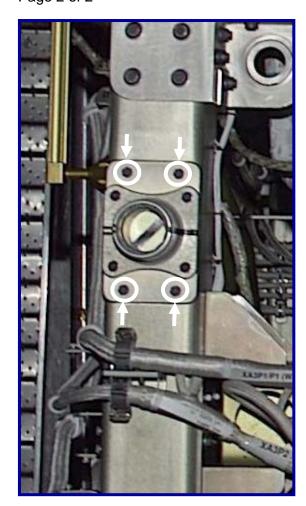
It has recently been identified that fasteners (circled in photo below) holding the WIF baseplates onto P6 could be loose. Note that the suspect fasteners are on the baseplate not the actual WIF itself. P6 WIFs 1 through 12 are suspect. You are using P6 WIF 11 for temp stowage of an APFR between EVA 2 and 3.

In addition to the usual pull test to confirm the APFR is fully secure, please do the following:

- Confirm that these 4 bolts are present and visually secure (no gap)
- Firmly push and pull on the installed APFR in order to confirm the 4 bolts and baseplate is completely secure.
- Call MCC with the results.

- 49 No tethering of the APFR is required after it is installed.
- 50 If WIF 11 is found to be loose, we will use P6 WIF 4A instead.
- 51 Only temp stowage of APFRs in these WIFs allowed for now - no ingressed APFR ops.

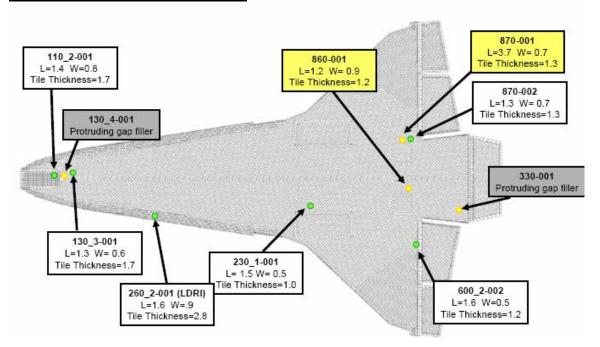
Figure 1: Tile/Gap Filler Summary.

The FD3 RPM data review has been completed and all TPS is clear for entry except for two protruding gap fillers and one tile area near the outboard edge of the port ET door which will likely be cleared tomorrow. One of these gap fillers is near the arrow head tile directly aft of the nose landing gear door and the other is on an aft tile forward of the bodyflap. Aerothermal analysis including the possible tripped flow downstream of these gap fillers continues. Based on the data obtained through FD 4, the team does not currently believe that any gap filler removal is required. A summary of the gap fillers and minor tile damage are shown in the figures below.
